BELTZVILLE LAKE CONDITION REPORT, DAM, OUTLET WORKS AND SPILLWA--ETC(U)

LEHIGH RIVER BASIN  
POHOPOCO CREEK, PENNSYLVANIA  
**BELTZVILLE LAKE**

CONDITION REPORT

DAM, OUTLET WORKS & SPILLWAY,  
PERIODIC INSPECTION REPORTS NO. 3 & NO. 4,  
SEPTEMBER 1972 & AUGUST 1973

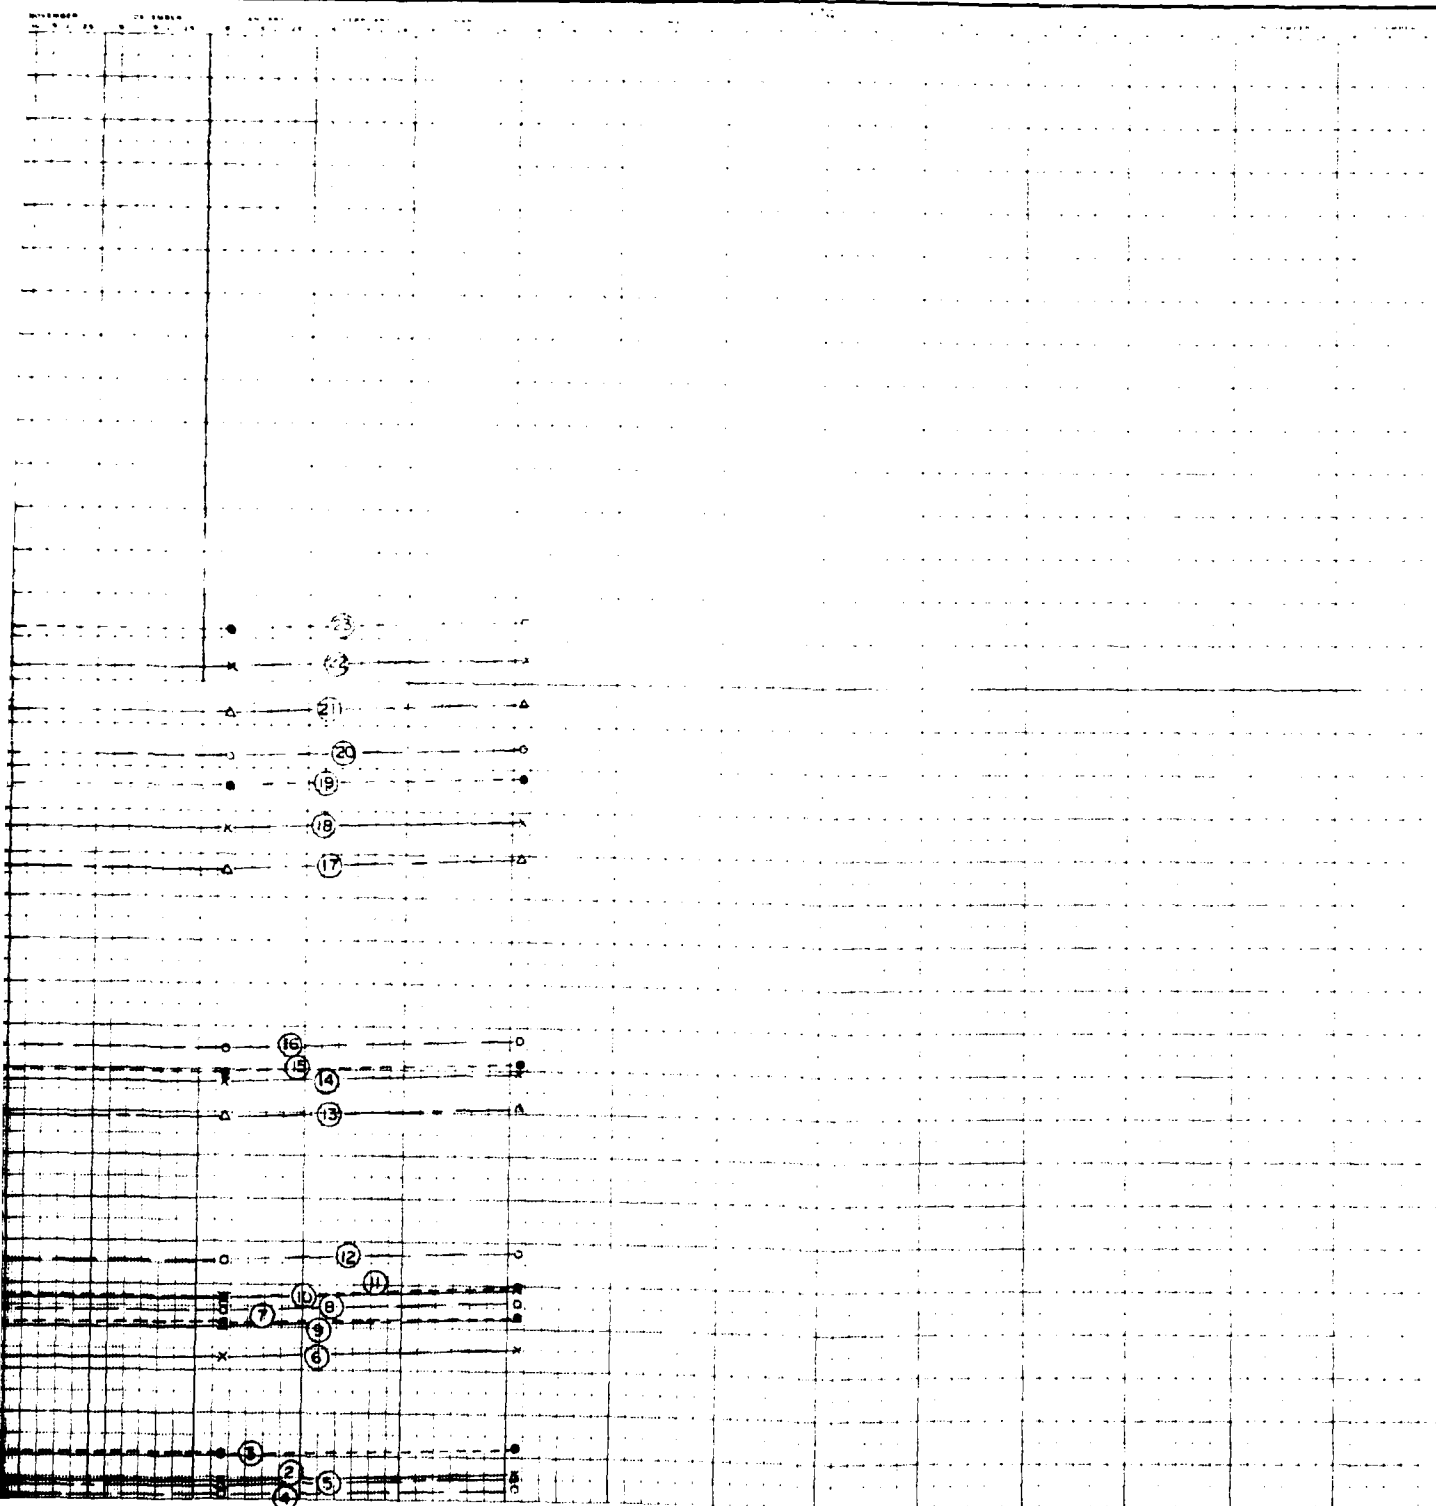
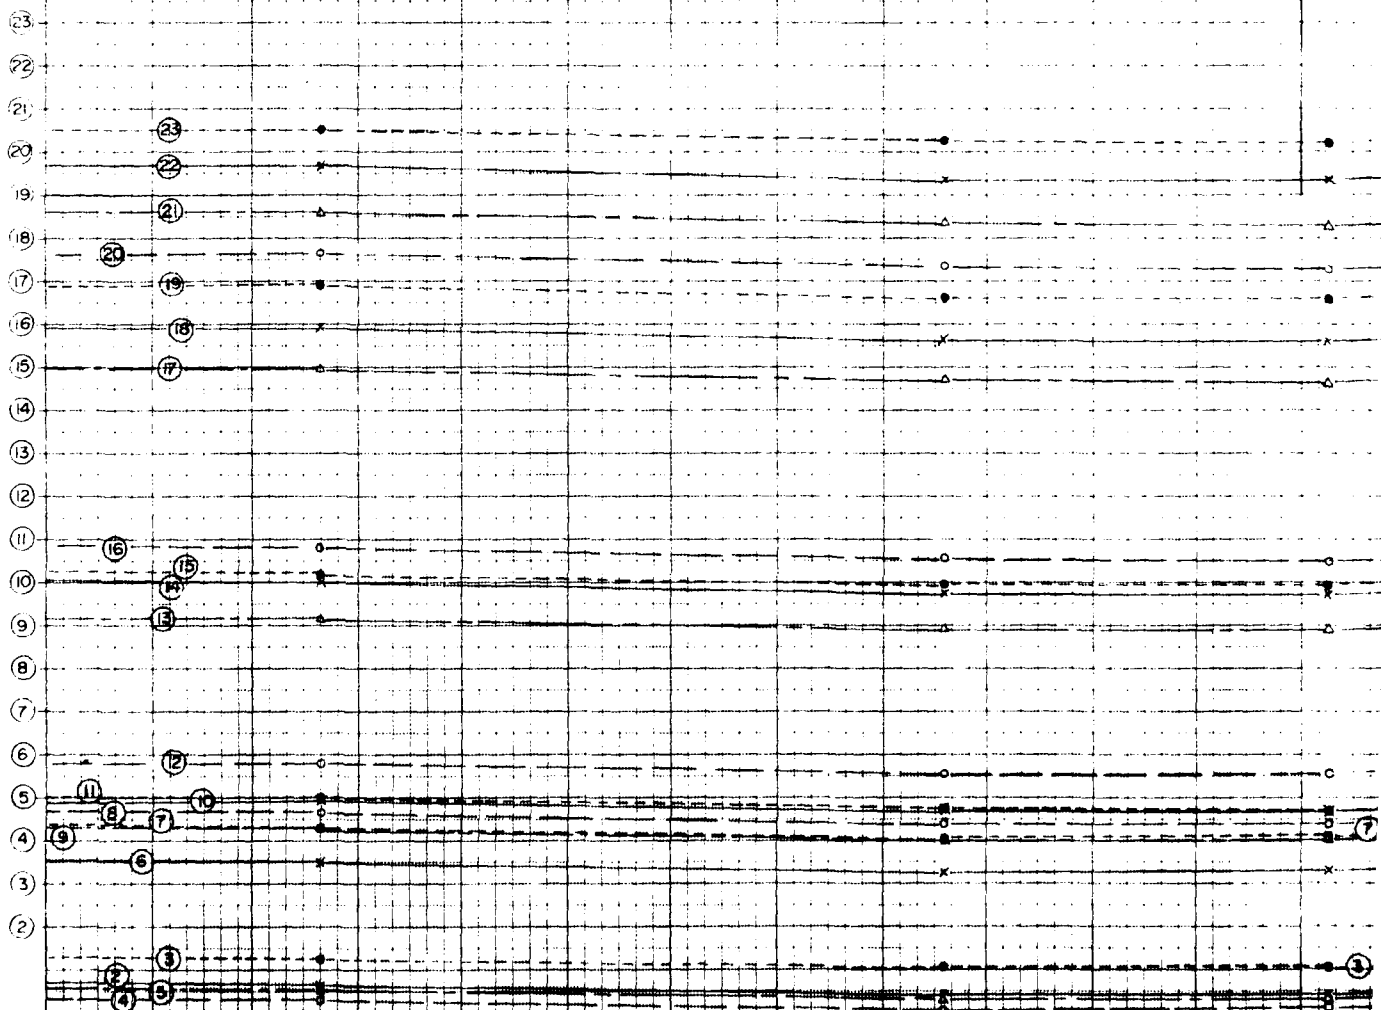
LEHIGH RIVER BASIN  
F. IOPOCO CREEK, PA.  
BELTZVILLE LAKE  
SUBSURFACE SETTLEMENT DATA  
VIF-98-5 1973-1974

Initial datum for settlement of section casing (2)

Measured settlement in section casing (2)

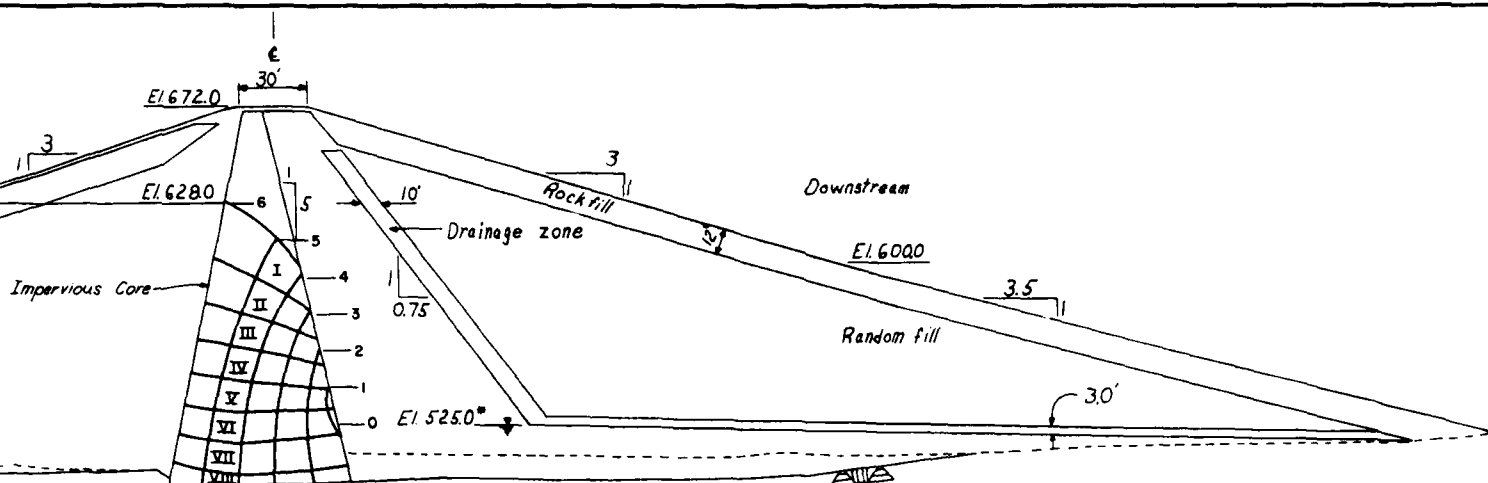
### CASE I.

Flow Net Values  $N_f = 7.3$ ,  $N_p = 6.0$

$$\text{Total} = 152 \text{ gpm}$$

$$\text{For } K = 0.00002 \text{ fpm, } Q = 15 \text{ gpm}$$

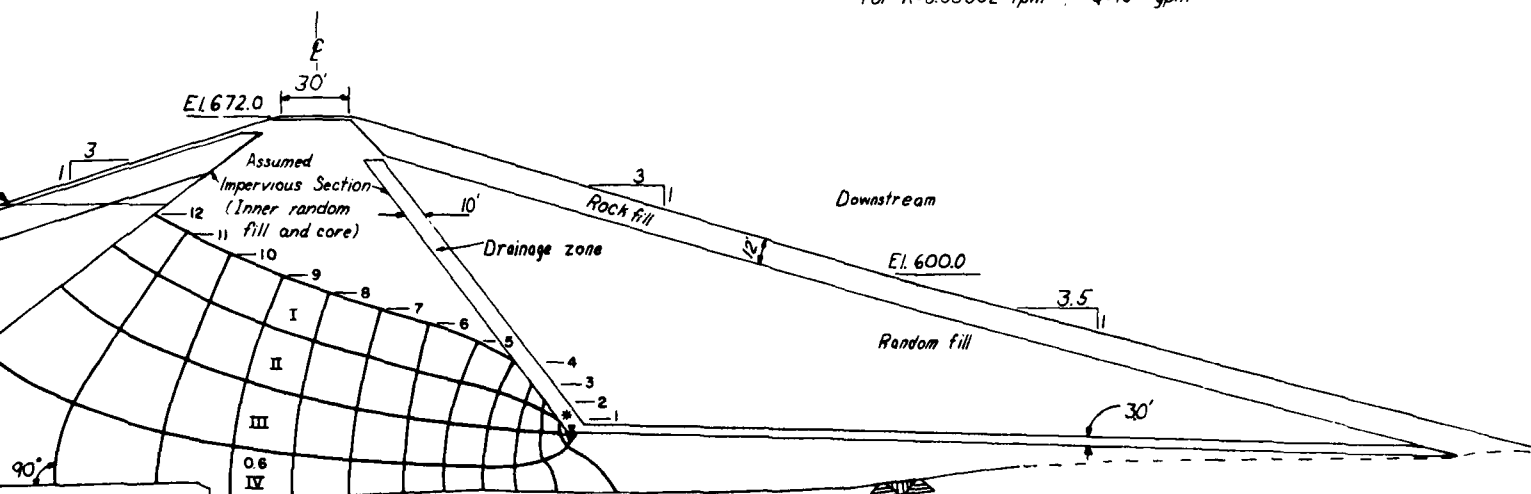
### CASE 2.

Flow Net Values  $N_f = 3.6$ ,  $N_p = 11.6$

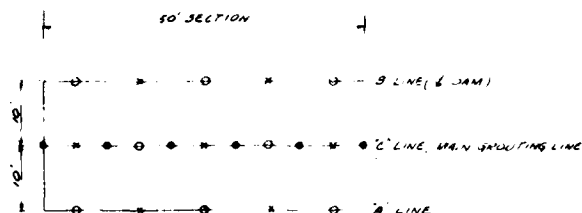
**MULTIPLE LINE GROUTING PLAN**  
SCALE 1"=100'-0"

- LEGEND
- PRIMARY GROUT HOLES
  - x SECONDARY GROUT HOLES
  - TERTIARY GROUT HOLES

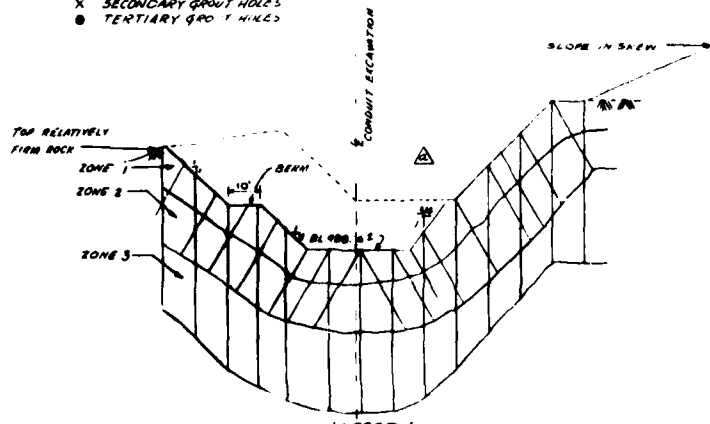
**INSERT 1**  
SCALE 1"=20'-0"

SECTION TAKEN PERPENDICULAR  
TO CENTERLINE OF CONDUIT  
ELEVATION OF TOP OF CONDUIT  
AT CENTERLINE IS 154.85  
ELEVATION OF TOP OF CONDUIT  
AT CENTERLINE IS 154.85

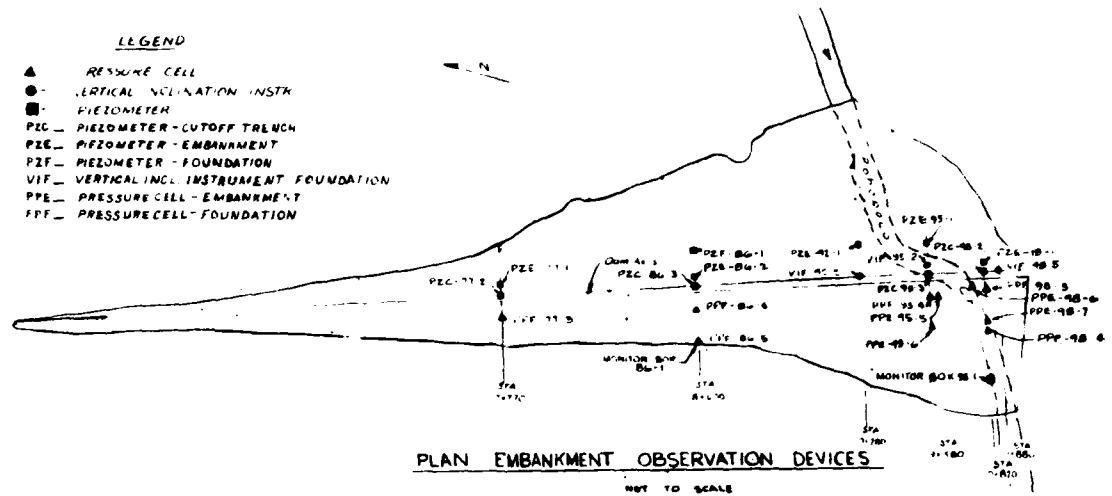
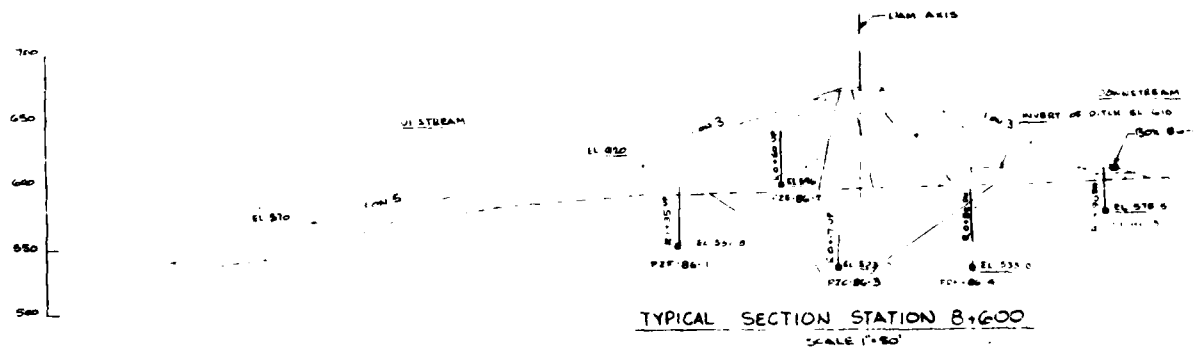
GAGE NO.	STATION	RANGE	ELEVATION	MATERIAL	TYPE OF INSTALLATION
PIE-77-1	7+770	0+60 UP	610.3	EMBANKMENT	PIEZOMETER
PIE-77-2	7+770	0+7 UP	578.3	CUTOFF TRENCH	"
PPF-77-3	7+770	0+68 DN	584.4	FOUNDATION	PRESSURE CELL
PIE-86-1	8+600	1+35 UP	581.5	"	PIEZOMETER
PIE-86-2	8+600	0+60 UP	596.6	EMBANKMENT	"
PIE-86-3	8+600	0+17 UP	583.0	CUTOFF TRENCH	"
PPF-86-4	8+600	0+88 DN	572.5	FOUNDATION	PRESSURE CELL
PPF-86-5	8+600	1+90 DN	578.5	"	"
PIE-98-1	9+820	1+35 UP	513.1	EMBANKMENT	PIEZOMETER
VIF-98-2	9+820	0+17 UP	515.5	FOUNDATION	VERT. INSTR.
VIF-98-3	9+820	1+35 UP	508.3	EMBANKMENT	PIEZOMETER
VIF-98-4	9+820	0+80 UP	508.5	FOUNDATION	VERT. INSTR.
PIE-98-5	9+820	0+17 UP	501.8	CUTOFF TRENCH	PIEZOMETER
PPF-98-6	9+820	0+80 DN	482.2	FOUNDATION	PRESSURE CELL
VIF-98-7	9+820	0+60 UP	565.9	EMBANKMENT	PIEZOMETER
PIE-98-8	9+820	0+17 UP	582.0	CUTOFF TRENCH	"
PIE-98-9	9+820	0+80 DN	588.2	FOUNDATION	PRESSURE CELL
PPF-98-10	9+820	1+90 DN	498.8	"	"

VIF-98-11	9+820	0+17 UP	550.0	"	VERT. INSTR.
PPE-98-12	9+820	0+80 DN	482.2	FOUNDATION	PRESSURE CELL
PPE-98-13	9+820	1+80 DN	523.8	"	"
PPE-98-14	9+820	0+80 DN	510.2	"	"
PPE-98-15	9+820	1+90 DN	510.2	"	"

The downstream pressure cells have shown rises in water pressure readings from 0 to 11 feet. The maximum 11 foot rise, recorded in pressure cell PPF 98-3, is well below the water level assumed during steady seepage design calculations and appears to be a normal condition.

Two downstream pressure cells have become inoperative since their installation into the embankment and contributed little information prior to malfunction. The reason for the malfunctions are not apparent at this time. District personnel are presently planning to replace the inoperative pressure cells with Casagrande-type open piezometers since these instruments appear to provide more serviceability and reliability.

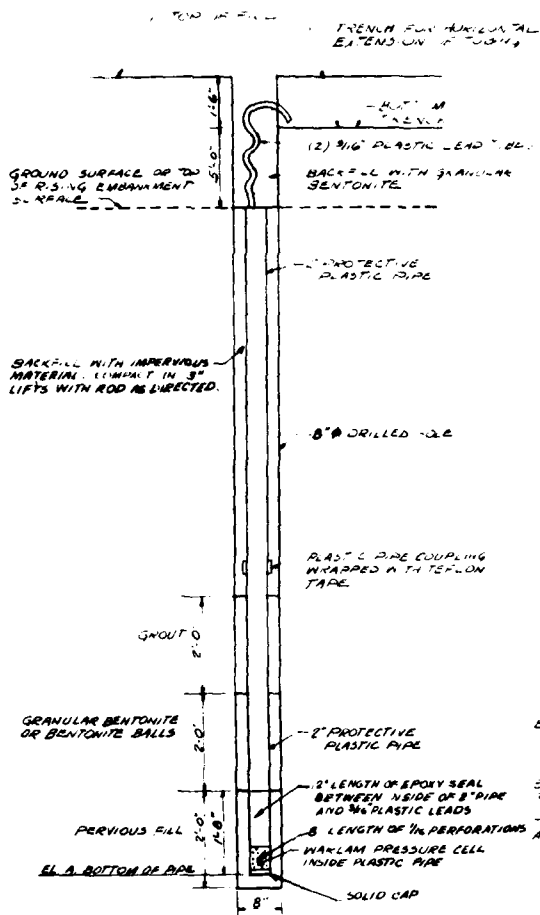
**PRESSURE CELLS-INSTALLATION**

NOTE  
TEMPORARY G CASING WILL  
BE REQUIRED DURING INSTALLATION

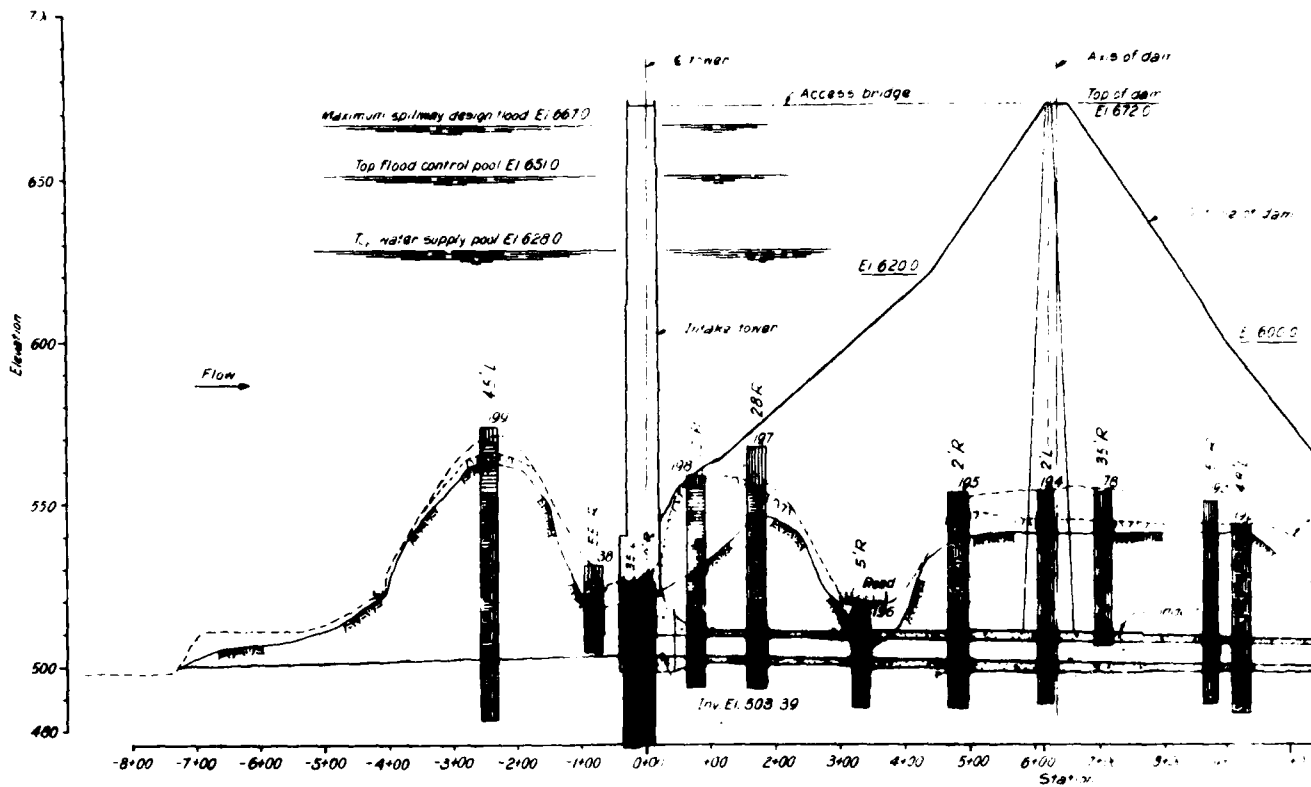
**PROFILE ON S CONDUIT**

Horizontal scale = 1" = 100'  
Vertical scale = 1" = 10'

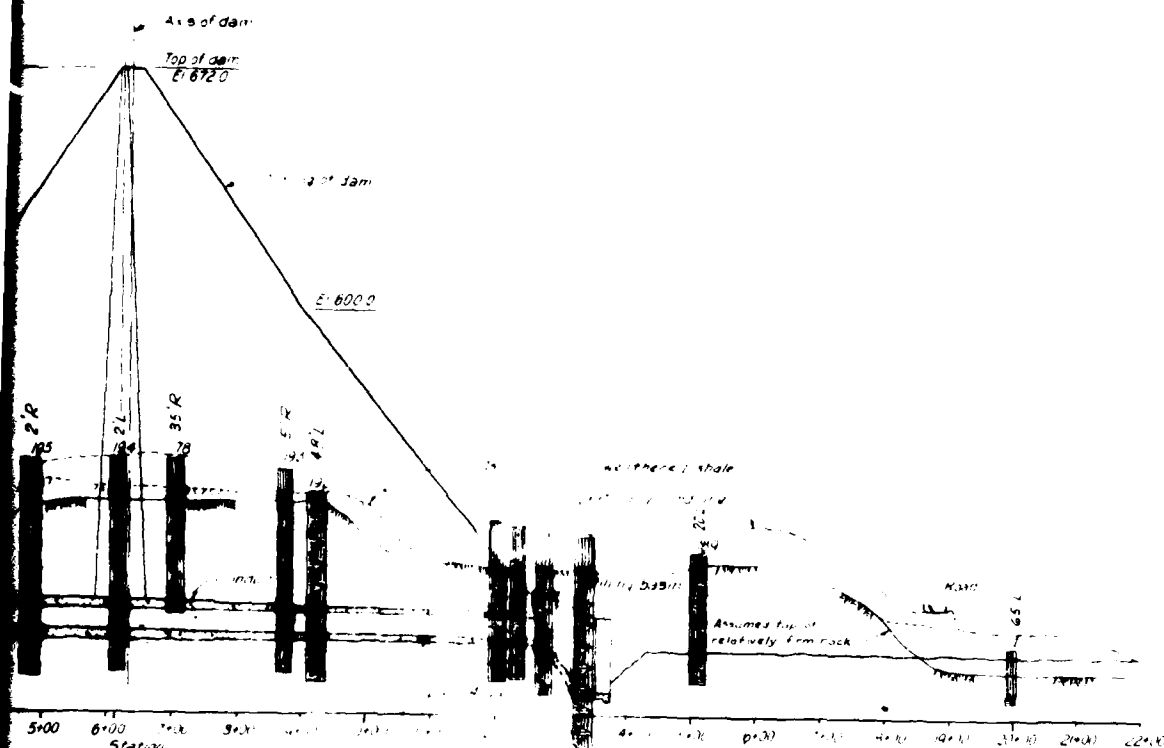
## PROFILE ON &amp; CONDUIT

Horizontal scale = 100:1  
Vertical scale = 10:1

LEGEND	
Overburden	<p><b>ALLOUVIUM</b> Recent deposits consisting of pervious sands, gravels and occasional boulders.</p> <p><b>DRIFT</b> Glacially deposited heterogeneous mixture of clay through boulders, compact.</p> <p><b>XUTWASH</b> Glacial, predominantly stratified, silts and silty sands loose.</p>
Bedrock	<p><b>SHALE</b> Weathered highly fragmental, many clay filled joints.</p> <p><b>SHALE</b> Relatively firm, predominantly dk-gray in color same sandstone beds.</p>
	Devonian Mahantong formation

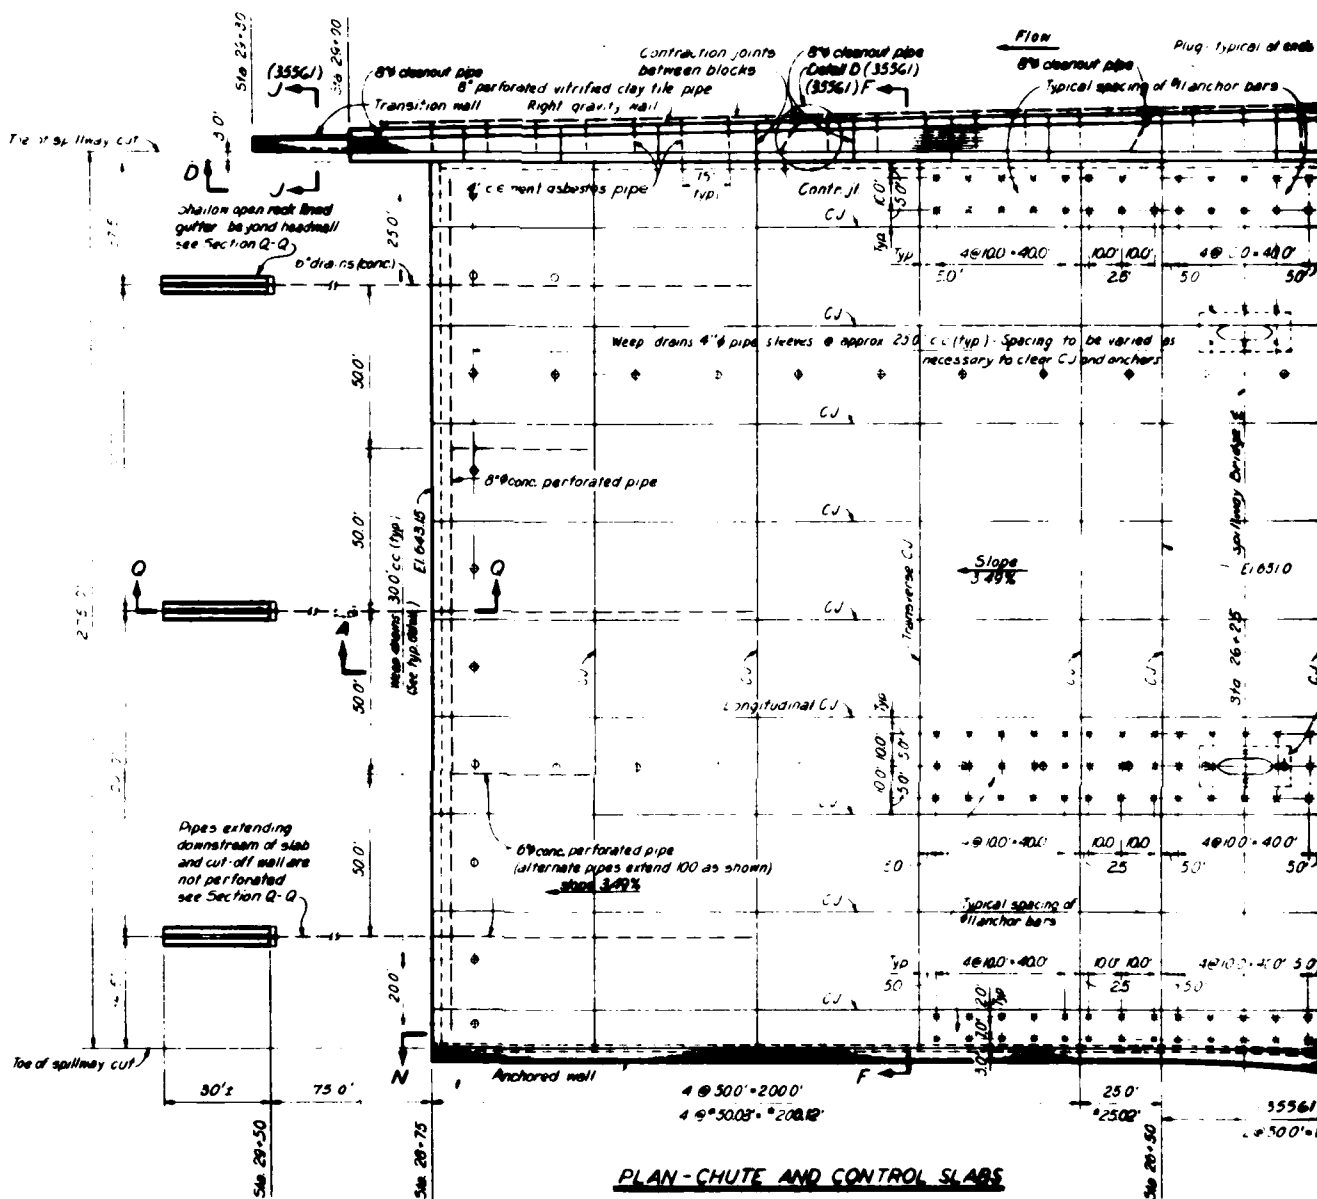
SECTION A-A

### PLAN-CHUTE AND CONTROL SLABS

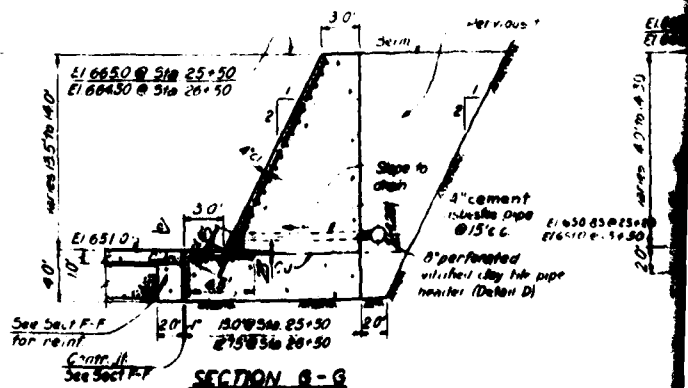
Actual Plans  
of Anchor Wall Southside Spwy  
Showing Thickness Variation

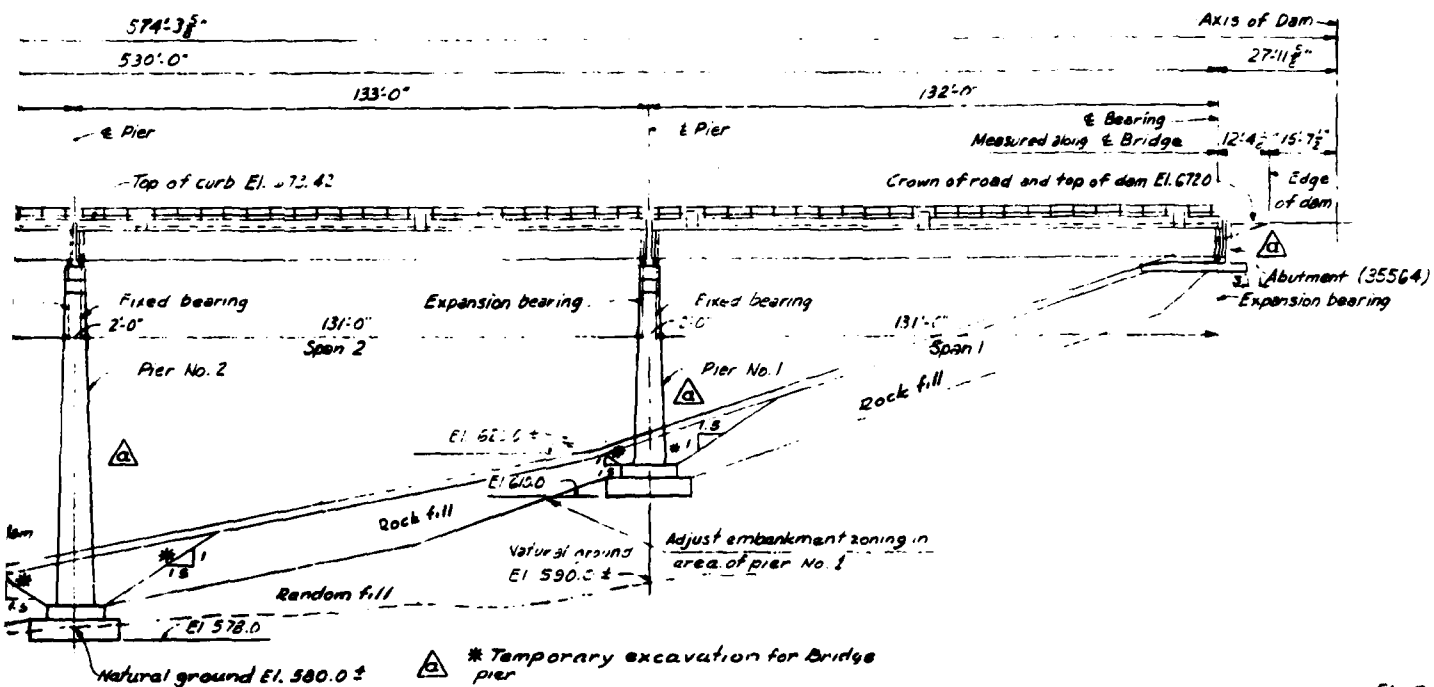
# **SECTION OF BRIDGE**

Scale: 1" = 20'-0"  
 5'-0" 20' 40'-0"

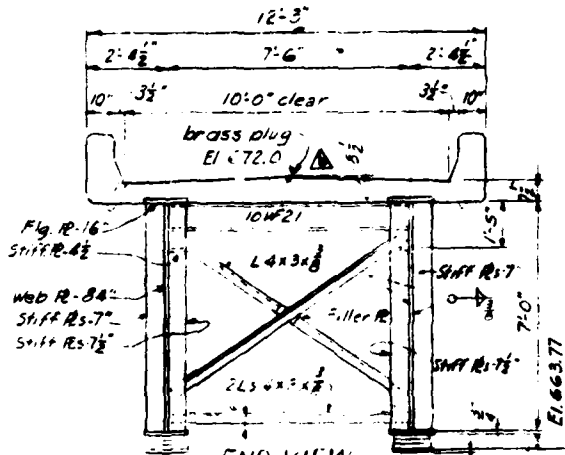
END VIEW

ERN FLOOR & ASSOCIATES, INC. CONSULTING ENGINEERS		U.S. ARMY ENGINEER DISTRICT, PHILADELPHIA CORPS OF ENGINEERS OFFICE OF THE DISTRICT ENGINEER	
CHARGE		ILLUSTRATION	
LEHIGH RIVER BRIDGE POTSDAM, NEW YORK BELTZVILLE LAKE			
SERVICE BRIDGE ELEVATION AND STRUCTURAL DETAILS SHEET 1			
DESIGN NO.	SIZE F	PROJECT NO.	35562
DATE AS NOTED		SHEET 37

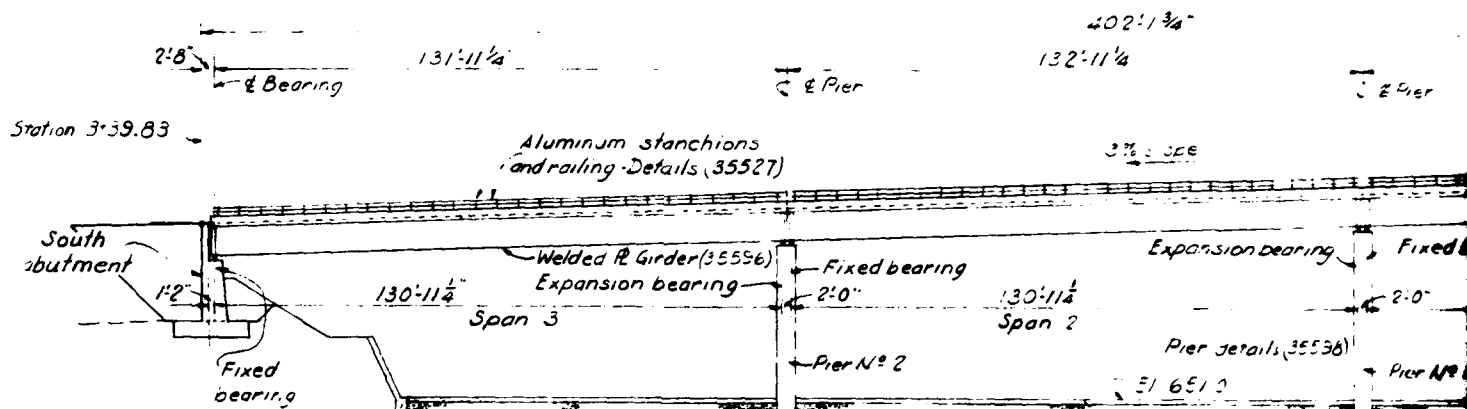
ELEVATION OF BRIDGE  
Scale 1" = 20'-0"

U. S. ARMY ENGINEER DISTRICT, PHILADELPHIA CORPS OF ENGINEERS OFFICE OF THE DISTRICT ENGINEER		
LEHIGH RIVER BASIN PONDPOOD CREEK, PENNSYLVANIA BELTZVILLE LAKE		
SPILLWAY BRIDGE ELEVATION AND STRUCTURAL DETAILS SHEET 1		
SIZE F	INV. NO.	DRAWING NO. 38896
SCALE AS NOTED		SHEET 121

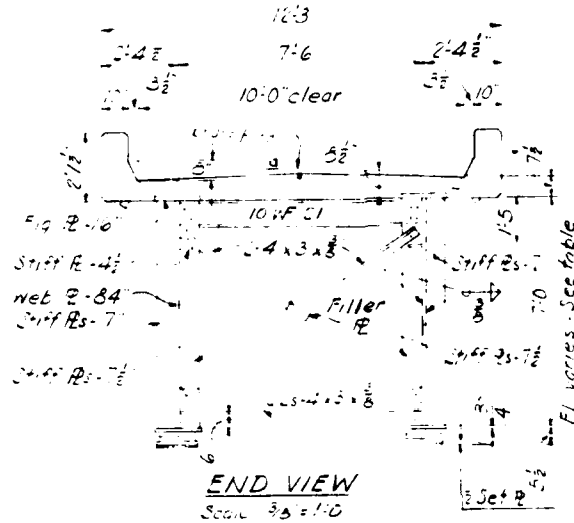
Location	Top of Pier or Abut	Top of Leveling R
North Abutment	694.74*	694.95
Pier No. 1, Span No. 1	690.78	691.02
Pier No. 2, Span No. 2	690.78	690.96
Pier No. 3, Span No. 2	686.79	687.03
Pier No. 4, Span No. 3	686.79	686.97
South Abutment	682.83*	683.04

\* On E of bearing
